# **WATER STORAGE TANK ANNUAL INSPECTION REPORT**

***Indian Lake Estates, Inc.***

***Ft. Meyers Dr. Elevated Water Tank***

***Date of Inspection: 09/05/2023***

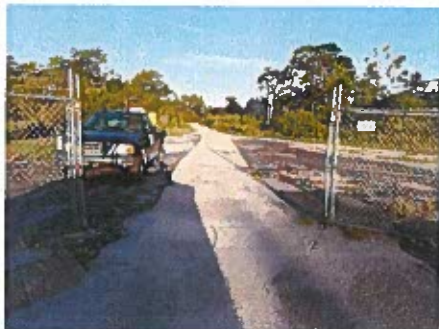
SITE ACCESSIBILITY

### Site Accessibility - **Compliant**

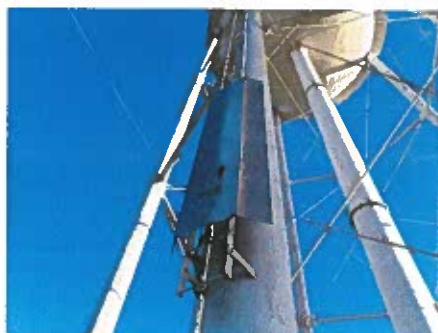
TRESPASS PREVENTION

### Trespass Prevention - **Compliant**

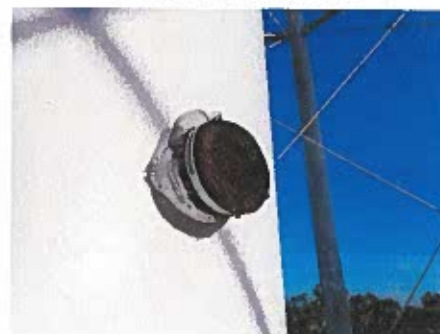
OVERFLOW PIPE DESIGN

### Overflow Pipe Design - **Compliant**

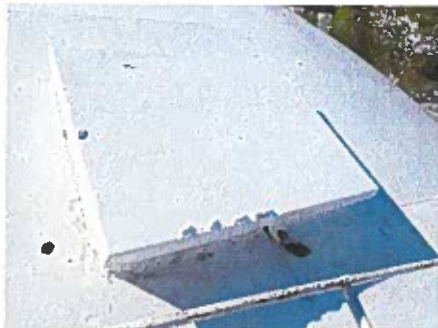
ACCESS HATCH PROTECTION

### Access Hatch - **Compliant**

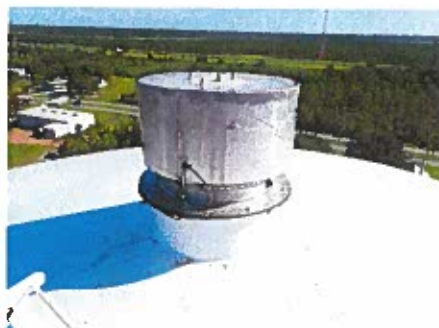
VENT DESIGN AND CONDITION

### Vent Design and Condition - **Compliant**

At the time of inspection, the existing vent was replaced with an aluminum vent that was bolted to the existing flange.
