# **WATER STORAGE TANK ANNUAL INSPECTION REPORT**

***Indian Lake Estates, Inc.***

***Ft. Meyers Dr. Elevated Water Tank***

***Date of Inspection: 03/24/2025***

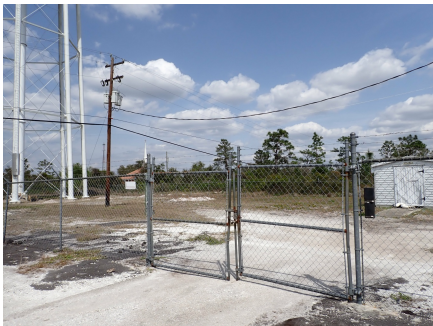
SITE ACCESSIBILITY

### Site Accessibility - **Compliant**

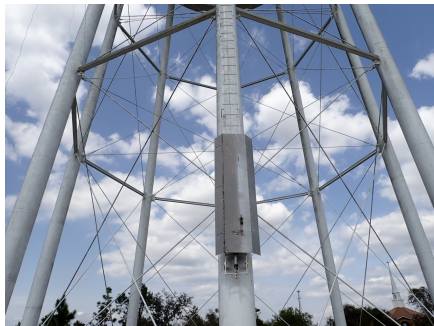
TRESPASS PREVENTION

### Trespass Prevention - **Compliant**

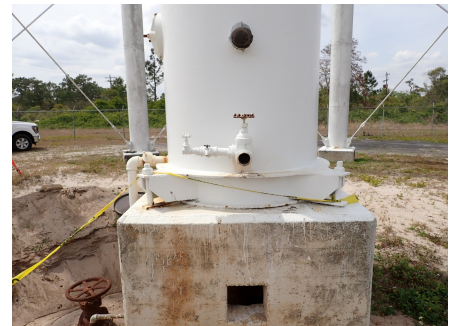
OVERFLOW PIPE DESIGN

### Overflow Pipe Design - **Compliant**

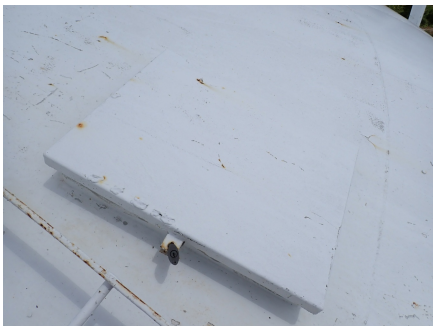
ACCESS HATCH PROTECTION

### Access Hatch - **Compliant**

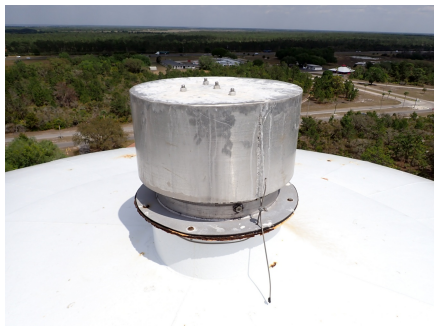
VENT DESIGN AND CONDITION

### Vent Design and Condition - **Compliant**
